Conservation Plan

William and Annice Matthias Residence – 723 Fourth Street, New Westminster

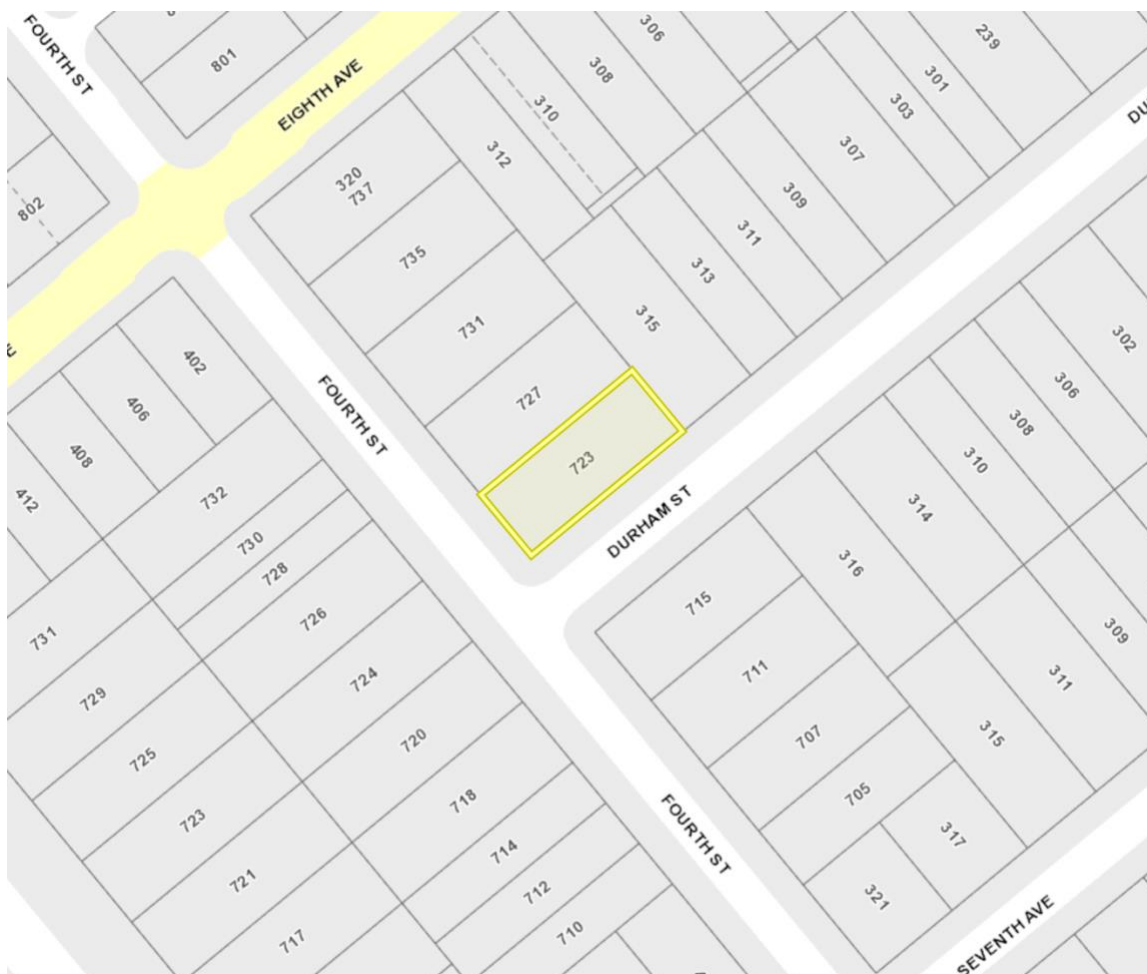
Figure 1: Location of 723 Fourth Street. City of New Westminster, CityViews Map.

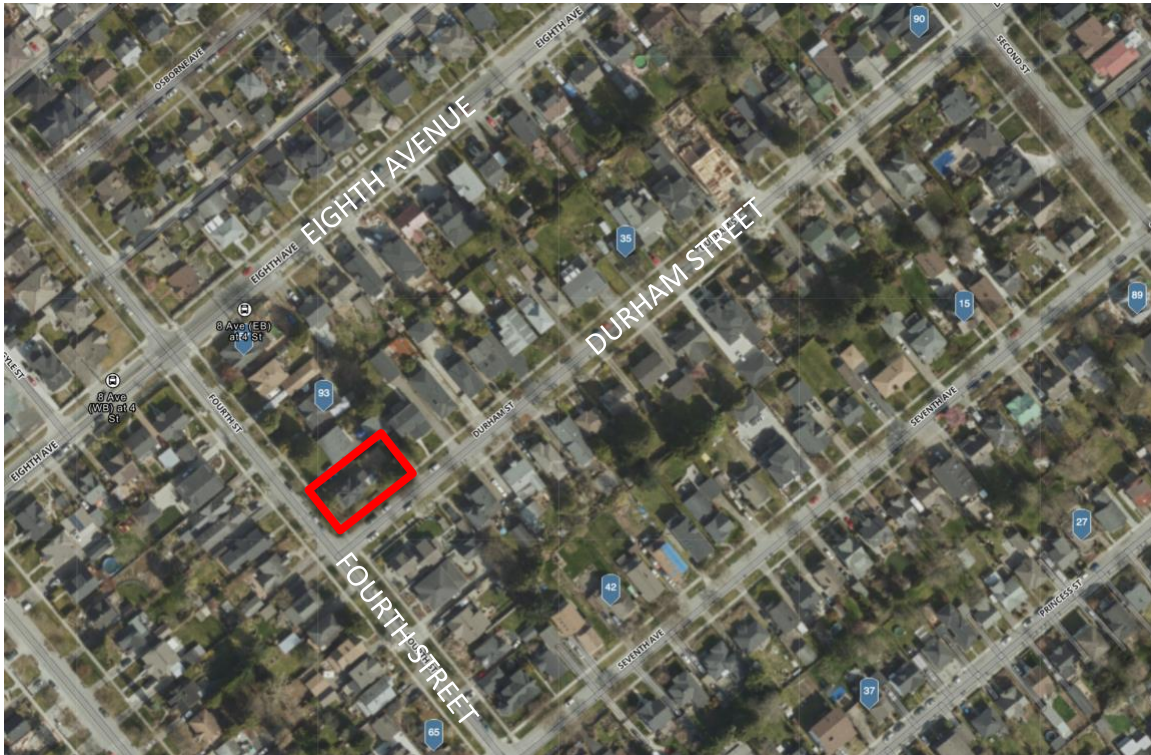
Figure 2: Aerial Photograph of Glenbrooke North area, with sites on the New Westminister Heritage Register. 723 Fourth Street is outlined in red.

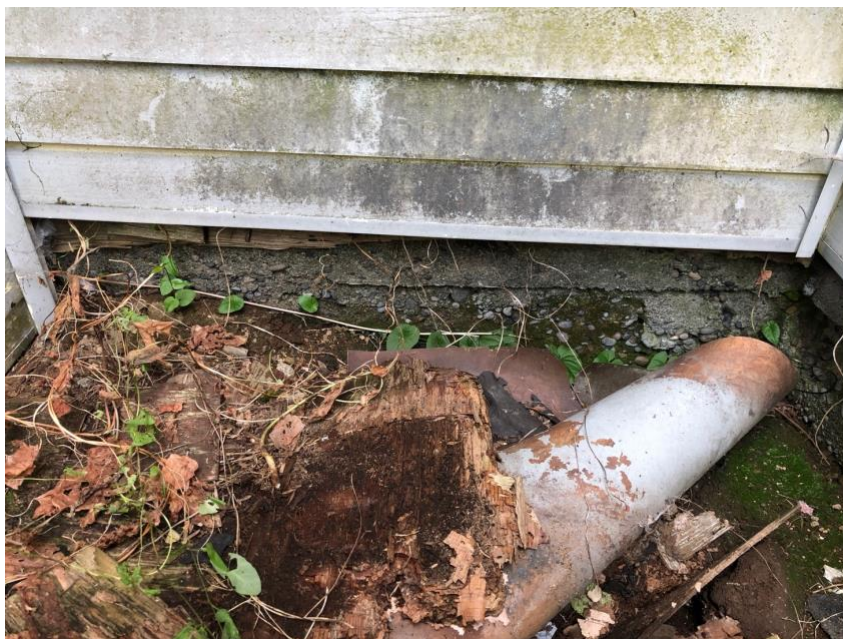
Figure 10: Concrete foundation

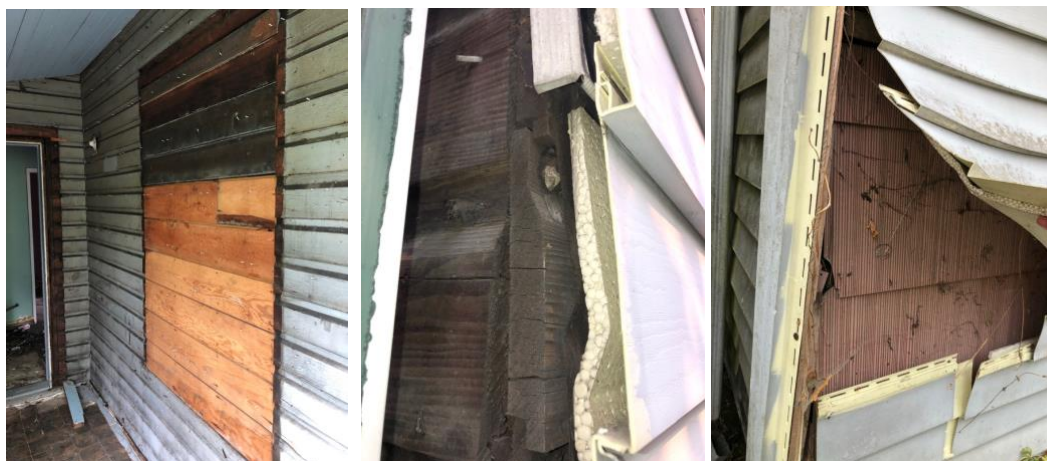
Figure 11: Original drop siding and profile (front corner); asbestos siding (north side)

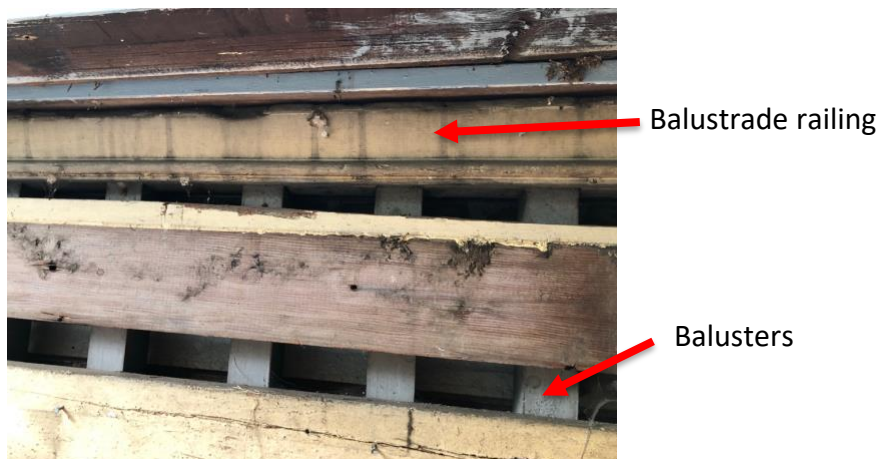
Figure 12: Balustrade with balusters visible behind horizontal enclosure boards

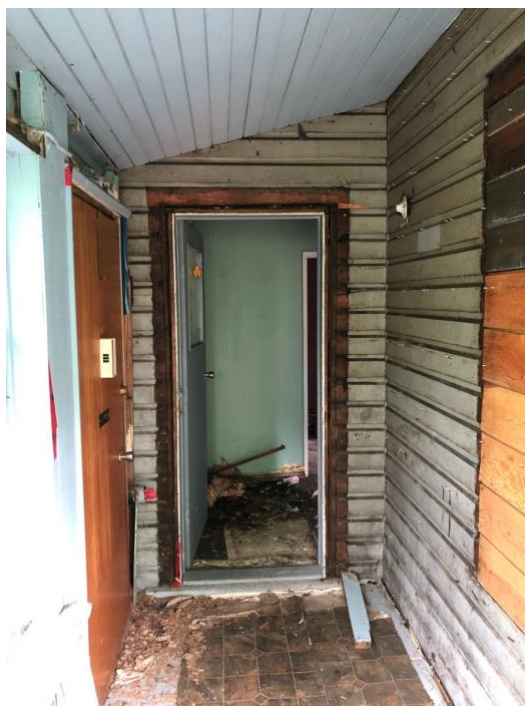
Figure 15: Original front door opening from the porch (centre); added front door on outer face of porch (left).

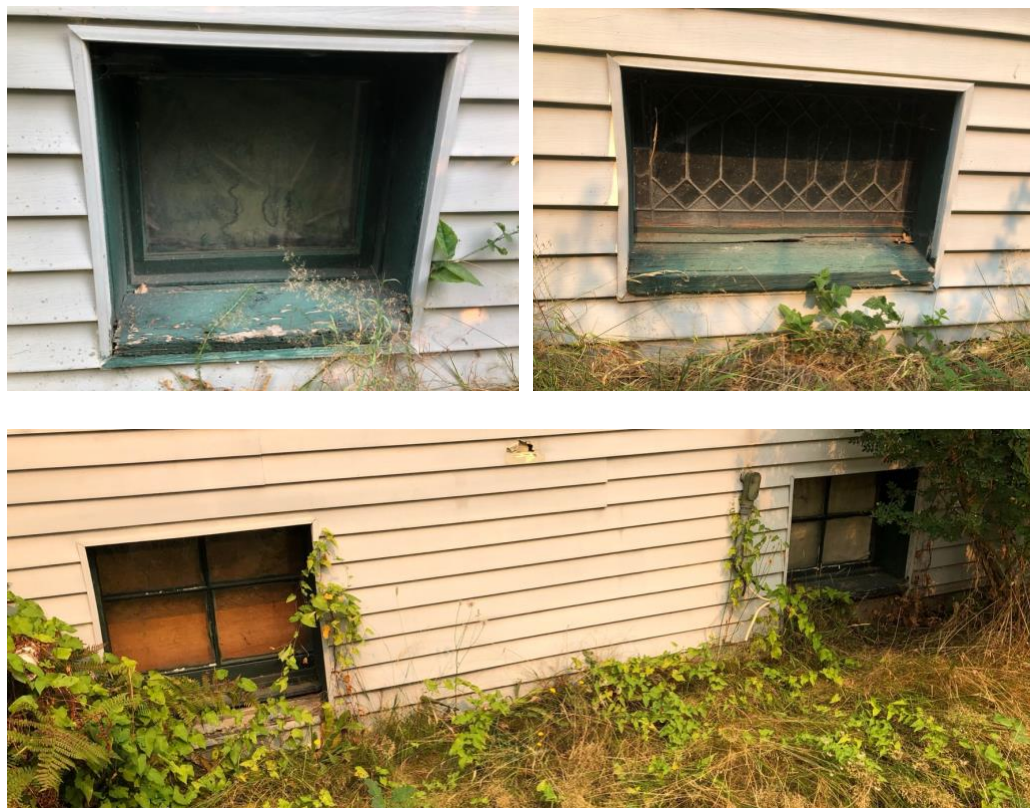
Figure 16: Basement windows, south side – clockwise from top: below porch, below front room, below kitchen.

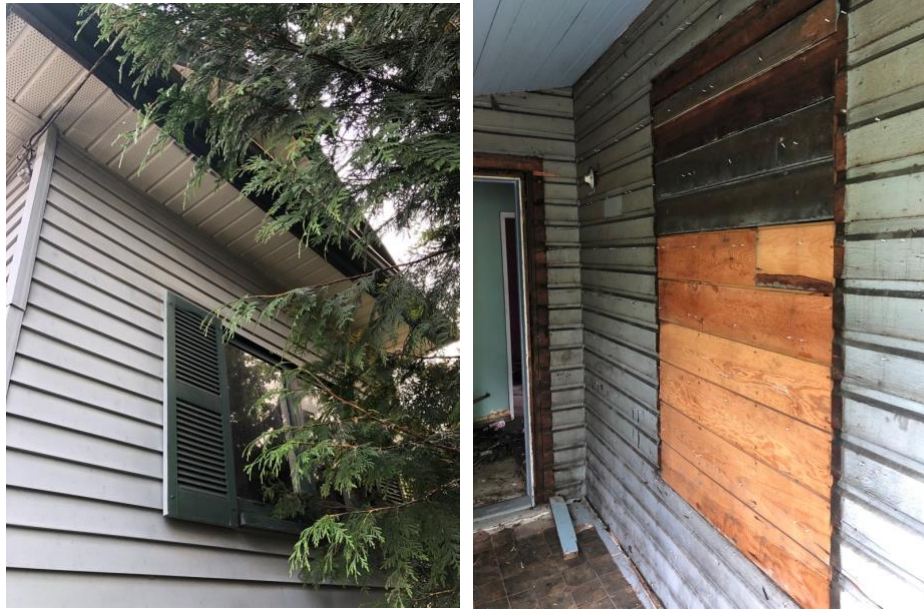
Figure 17a: Front windows

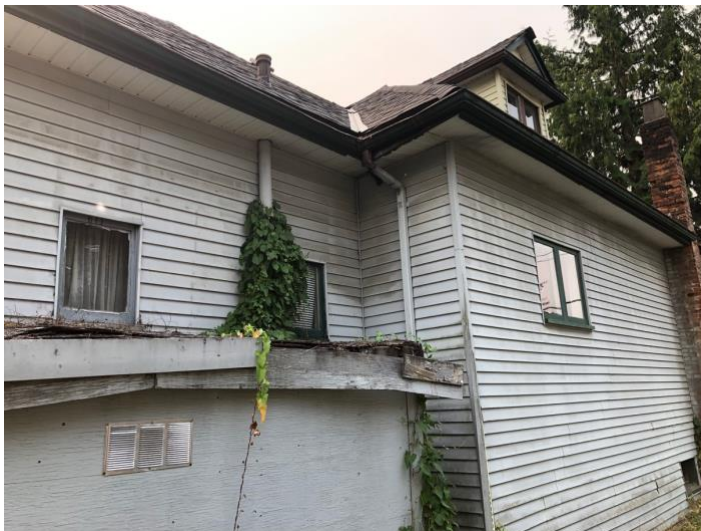
Figure 17e: North side windows

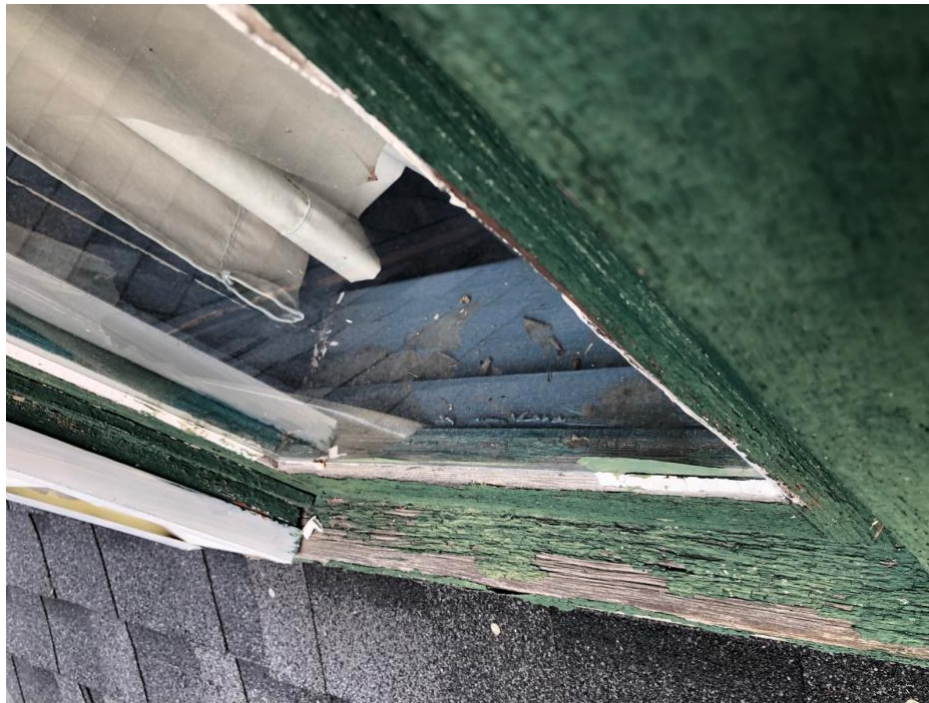
Figure 18a: Attic dormer window, sill and trim – west side (front).

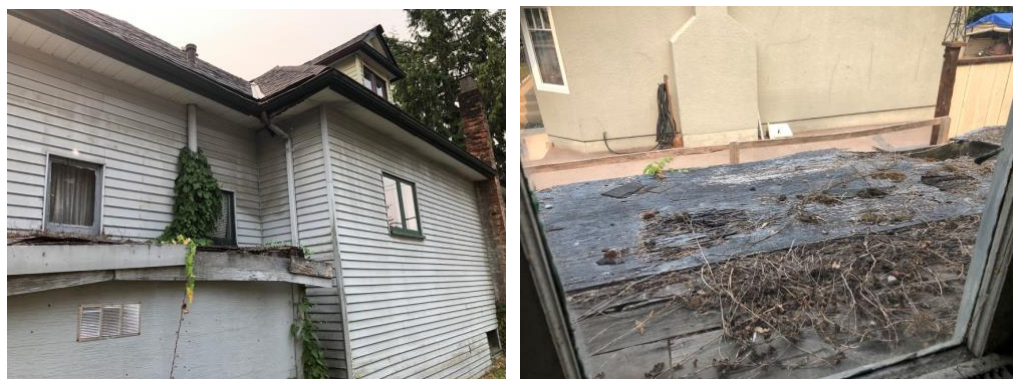
Figure 19a: Soffits and gutters on the north side, deteriorated roof covering storage area on north side

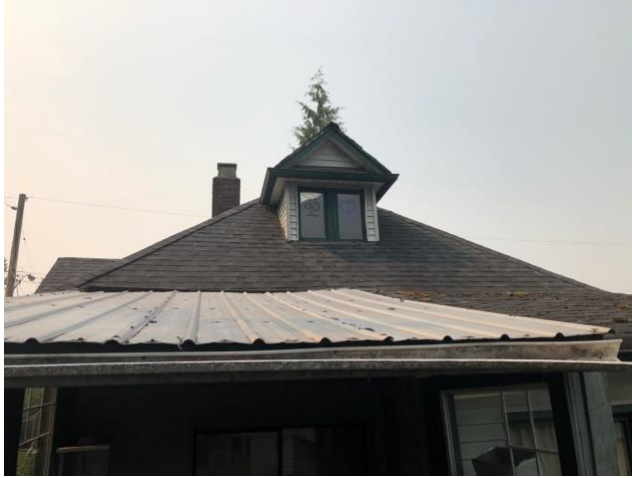
Figure 19b: Roofing as seen from the rear

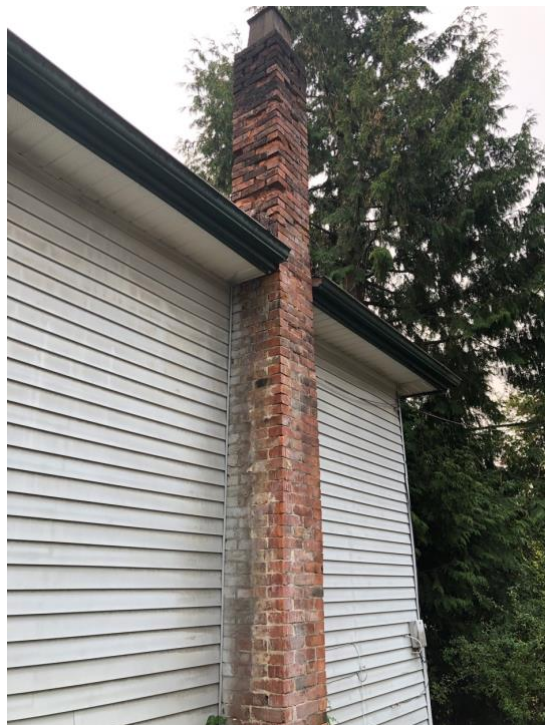
Figure 20: Deteriorated chimney on north side

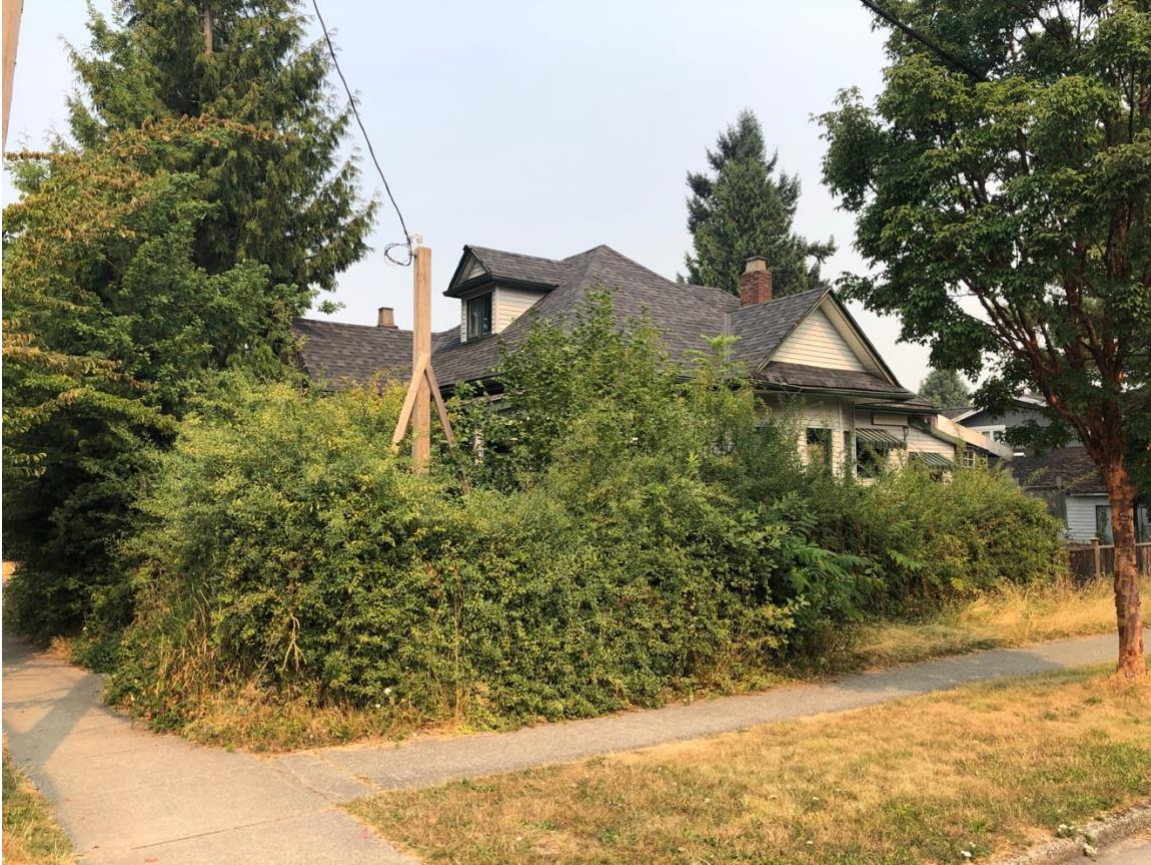
Site overview: Partial west and south side, as seen from Durham Street. The house is positioned close to both the front and side property lines and, removing the overgrowth, would be prominently placed at the corner of Fourth Street and Durham Street.
